Manhole Inspection Summary

Manhole # S130__013MH

Location Address: **403 Parksley AV**

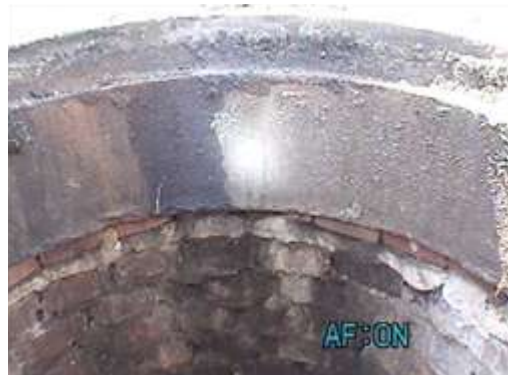
Defect 3

☒ **Leaks**

infiltration from lid (Oily film infiltrating)

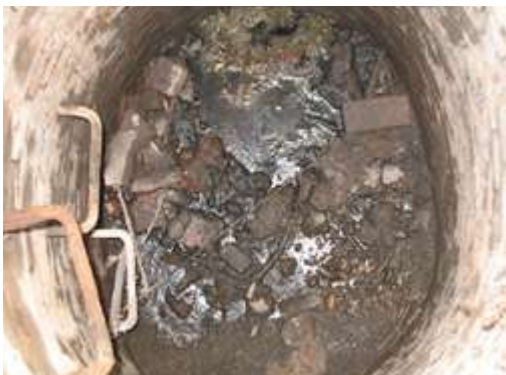
Defect 2

Condition: ☐ Sound ☐ Cracked ☐ Root Intrusion ☐ Deteriorated ☐ Leaks ☒ **Debris**

Channel debris (could not get measurements)

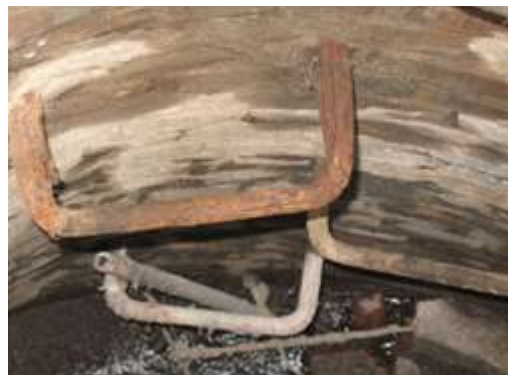
Defect 1

Infiltration: ☐ None ☐ Joint ☐ Cracks ☐ Mortar ☐ Roots ☒ **Wall**

☒ **Corroded**

steps corroded and barrel infiltration at wall

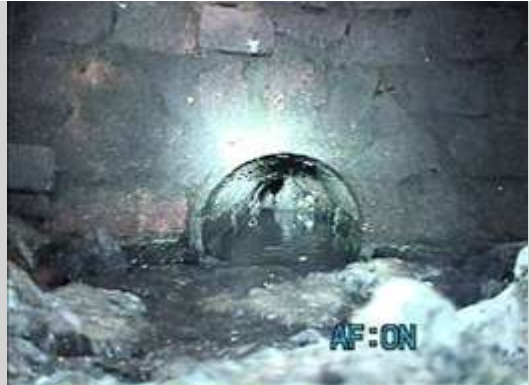
12 O'Clock Outflow

Infiltration: **Evidence** Pipe Seal Cond: **Unknown**
